MCNAB *Sport*

Hörger SBK 1500

2G & 3G Artificial Turf Cleaner

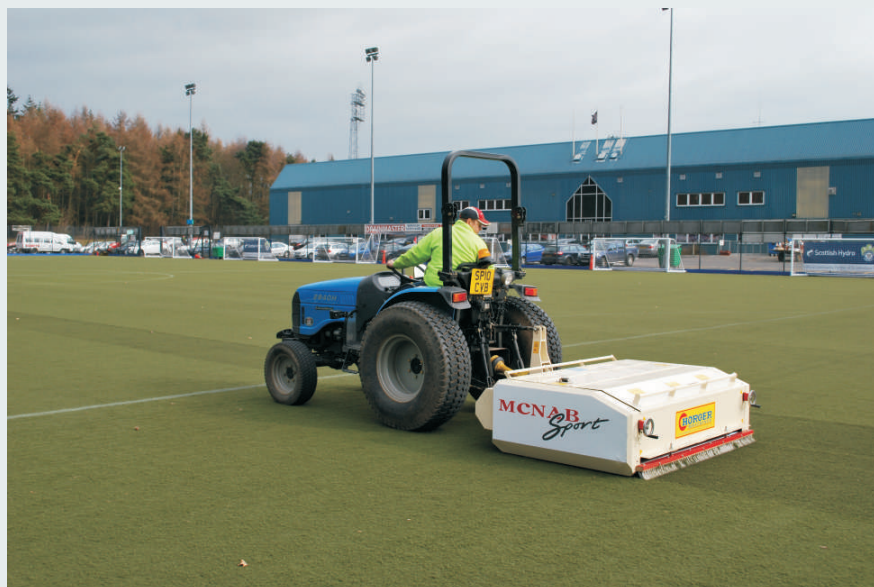
Intensive cleaning & loosening of the surface where the filling is loosened with the removal of plant debris and where drainage is being affected.

Required once or twice a year depending on contamination and usage.

May require one or two passes.

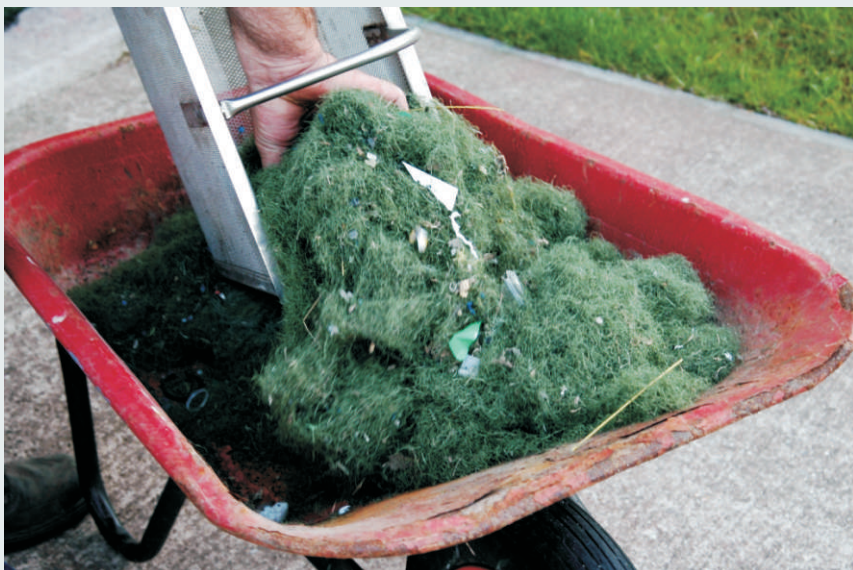
Reactivation of the surface which has been untreated for several years

All the compaction is broken up and the infill loosened and brought back into the turf pile. Coarse soiling is removed and any fine particles responsible for the hardening are filtered. The artificial turf becomes loose & flexible again, drainage effect is repaired and the risk of accidents is decreased.

This operation may require up to three passes with the turf cleaner, depending on the degree of contamination.
